# Structural Auditing with a Case Study

J. M. Sadamate<sup>1</sup>, Dr. G. A. Hinge<sup>2</sup>  
ME (CM) Student<sup>1</sup>, Vice-Principal<sup>2</sup>  
Department of Civil Engineering

Name of Building:Renuka Residency

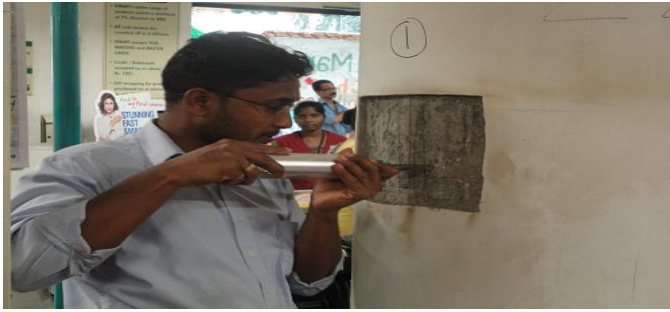
**Figure.2. Rebound Hammer test**

It was designated as **Bldg. No. 1** for study purpose. It's a Renuka Residency catering needs of Katraj kondwa road,. The Building is 13 years old. Grade of concrete used was M25. It is G+8 storeyed building. The ground floor and first floor used as commercial complex and the 2<sup>nd</sup> floor is used as a parking for the customer of shopping complex. The Owners have observed corrosion related cracks on slab bottom; beams and columns hence they wanted to know the strength & quality of the concrete. Hence they appointed M/s. BHOOMI GEOTECH PVT.LTD. For assessing the strength & integrity of concrete elements of this building by carrying out non-destructive testing. As a fig 1 showing the internal surface of the concrete to conduct rebound hammer test and fig.2 showing technician Mr. Tulsi, Bhoomi Geotech Pvt. Ltd. performing Rebound Hammer test on actual site.
