Analysis of Locomotive Brake-Hanger Failure

Keywords: Locomotive, Hanger, WAG-9, Failures.

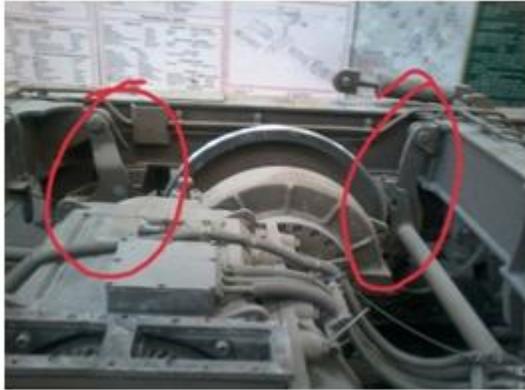
Figure.2. Brake Hanger Assembly

The braking system of WAG-7 and WAG-9 loco are identical in all respect of its working, the bogie and brake rigging. Of late, Railways have reported and failures of brake hangers in WAG-7 locos only from 2004. The brake block holders are prevented from dropping to the ground by brake hangers, to which they are connected by the lower brake hanger pins. The upper part of the brake hangers are connected to brackets on the bogie frame by the upper brake hanger pins. The brake head pins and the upper and lower brake hanger pins are all secured using washer and split pins. The brake beam, however only control the movement of brake blocks in horizontal plane and provides no vertical restraint. The upper part of the brake hangers are connected brackets on Bogie frame by the upper brake hanger-pins. The

typical brake hanger assembly in a locomotive and the material properties of hanger are as follows:

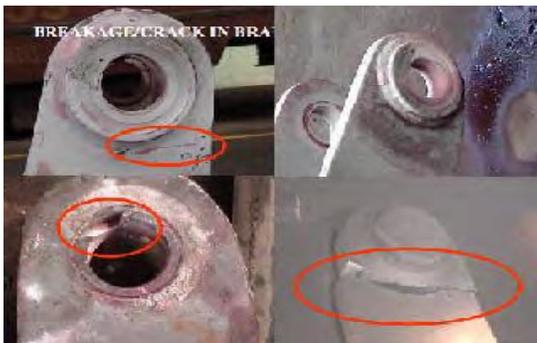
Figure.3. Various Type of Hanger Failure

1. The main reason to failure hanger is manufacturing defects and aging.
2. Initiation of failure at the neck of hanger, the root cause for it is the formation of micro cracks during welding.
3. 100% of the breakage took place at the top of the hanger plate and just below the welding done for fixing of additional ring to enable fixation of bush of 20 mm width.

4. Hanger fails in the dynamic condition.
5. The maximum failure occurring at the top part of the bush.
6. If wear of the bush is more than the 4 mm diametrically it is not fit for operation.
7. The brake hanger usually fails during running condition after certain period.
8. Both the inner as well as outer hangers are braking but the breakage of inner hanger towards bogie frame is much more with 80% of total failures
9. 100% of breakages at the top of hanger plate.

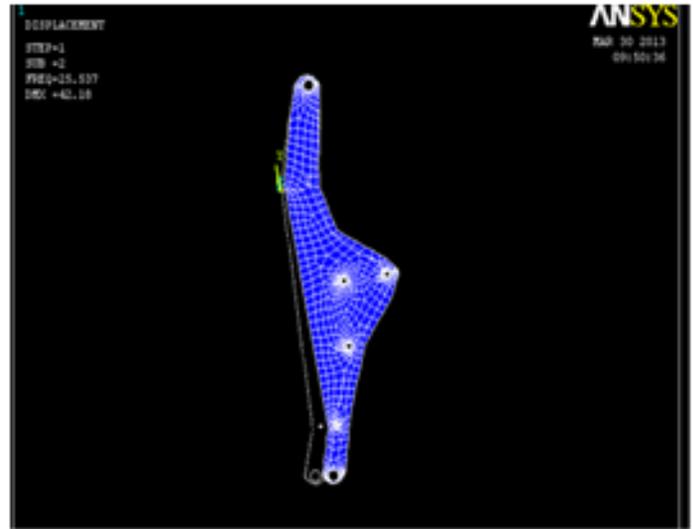
Figure .4. Model of brake hanger

The above observed failures in brake hanger could be analyzed by using ANSYS. The following are the outcomes for existing model.
