# Probability Based Approach for Predicting Breach Width for Barak Valley, Assam

Korabi Das<sup>1</sup>, Dr. Mimi Das Saikia<sup>2</sup>  
M.Tech. student<sup>1</sup>, Professor<sup>2</sup>

Department of Civil Engineering  
Assam Down Town University, Guwahati, Assam, India

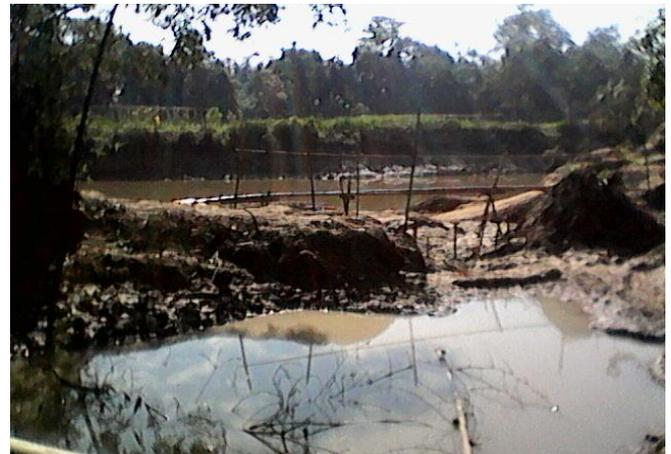
**Figure .3.1: Breaching occur in Longai River due to erosion**

It is observed that, severe bank erosion (for e.g embankment breaching occurs in Longai River on 2015 due to erosion as shown in figure1) and overtopping took place during the past few years. On observation, it is seen that due to concentration
